Update - Castle Rock County Water District

Facilities Condition Assessment and Evaluation

September 2015

Castle Rock County Water District Facilities Condition Assessment and Evaluation

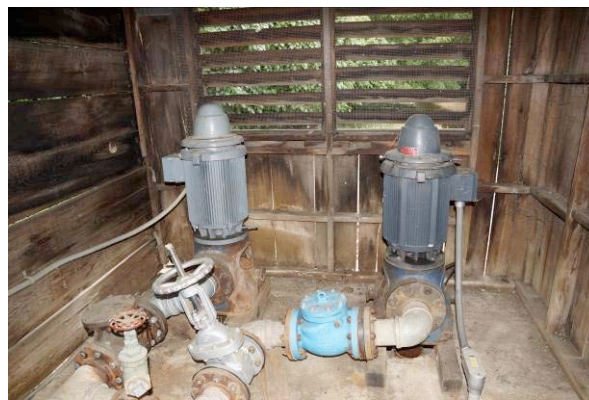
Figure 8: Pump Motors in Pump House

The pump house contains two motor and pump combinations, one 35 horsepower and one 25 horsepower motors connected to hollow shaft pumps. The pump house does not contain any standby power capabilities as the Board has determined that they are able to operate from the storage reservoir if there is an electrical failure.

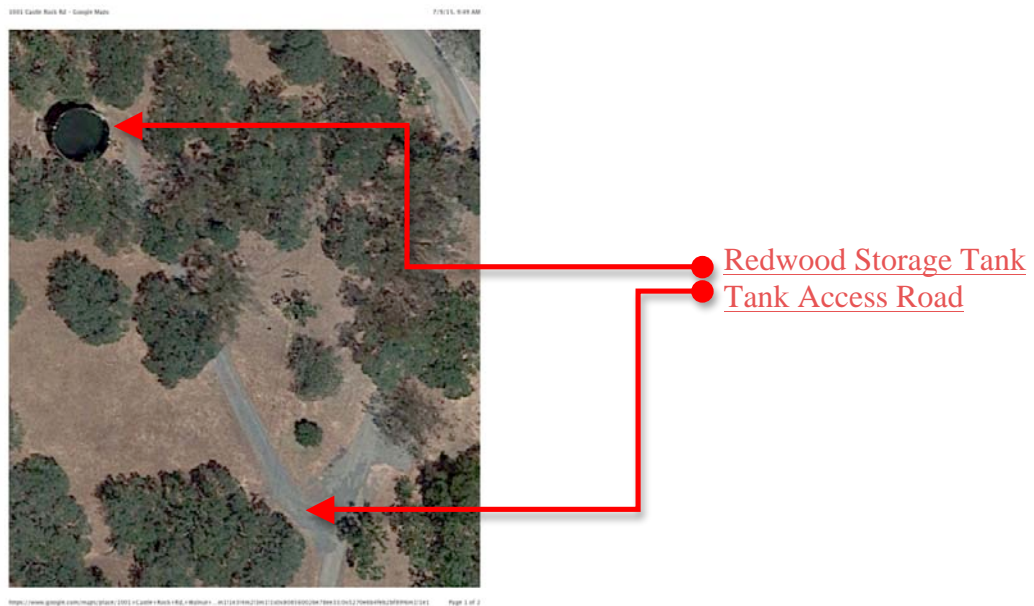
Figure 12: Aerial Photo of Redwood Tank Site

This tank was purchased used and installed in 1956 and was placed on a 34-foot diameter reinforced concrete engineered foundation. The tank is an open reservoir 33 feet in diameter with twenty (20) foot tall walls with an estimated capacity of approximately 125,000 gallons. The walls of the tank are secured in place with steel circumferential tension hoops. The rods are $\frac{3}{4}$ -inch threaded rods in horizontal rings spaced across the full height of the tank based upon the loads placed on the walls by the water in the tank.

Plans for this concrete foundation are included in the 1956 construction plans. The concrete base appears in good condition where visible as it rests on a rock base. Very minor spalling is localized to the eastern edge of the ring and no major cracks were seen during the field inspection of the exterior of the tank. No inspection of the interior of the tank was conducted as part of this work as the tank was in full operation at the time of the field inspection. The Board President indicates that the tank and the concrete base have never had any seismic problems or has experienced any known seismic damage. However there has never to his knowledge been any seismic evaluation of the storage tank before or since the original installation in 1956.

The tank access road (See Fig. 12) is steep and over the years has required maintenance to retain accessibility to the tank. The current road especially at the bottom is rutted where a sharp right turn off of the City dirt road is required. In addition, the road surface up the slope is gravel and dirt that appears to be in need of repair again. It was stated during the inspection that a four-wheel drive vehicle is required to access the tank site. It appears that the condition of the road during wet weather could create access concerns. The road has been regraded in 2007, 2008 and 2012 and should be considered for repair currently.

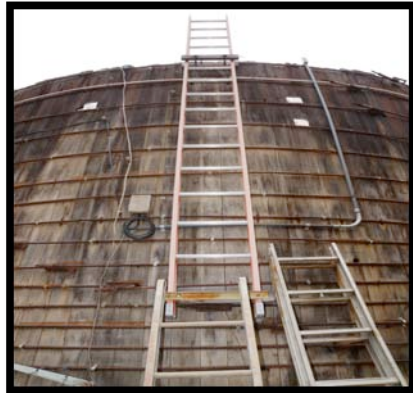
Figure 13: Tank Access Ladder, Ext.

The inside of the tank is accessed by ladders (see Figure 13 and 14 below) along the southern exposure of the tank and over the top and back down the inside of the tank. The access ladders are secured within a five-foot fenced area topped with barbed wire (See Figure 15 below). The District has purchased a harness climbing system for anyone using the access system. The tank does not contain any access hatches or man ways for entry into the tank from ground level.
