Update - Castle Rock County Water District

Facilities Condition Assessment and Evaluation

September 2015

Castle Rock County Water District Facilities Condition Assessment and Evaluation

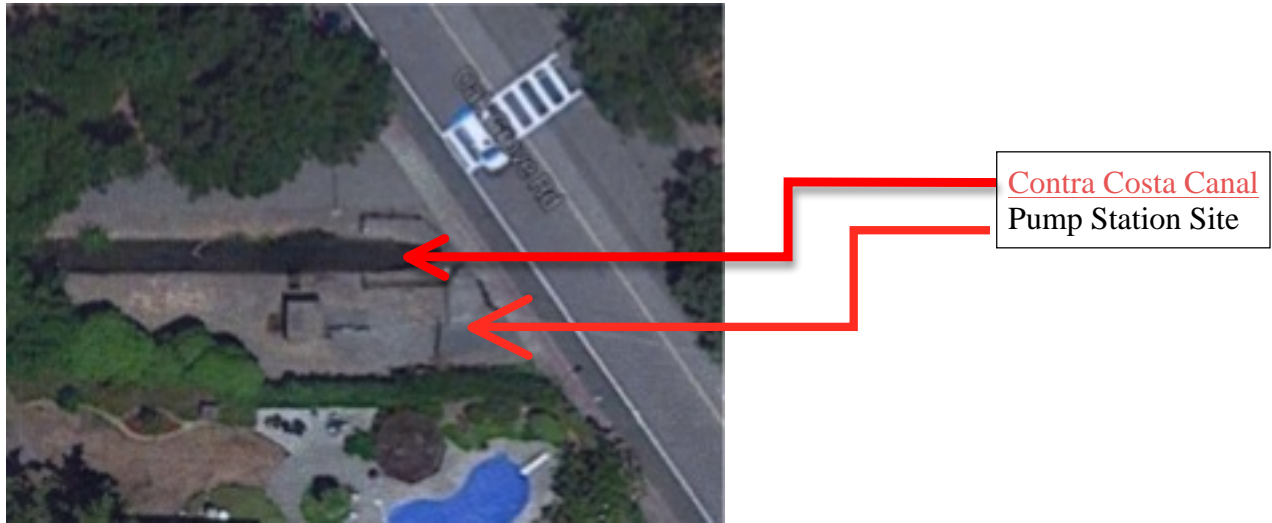
Figure 4: Pump Station Site

The District purchases all water distributed in the service area from the CCWD canal located along the southbound lane of Oak Grove Road in Walnut Creek between Filbert Drive and Walnut Avenue. See Figure 4 below. The pump station inlet is located on the west side of Oak Grove Road and the south side of the canal. The pump station is located within a six foot fenced area immediately adjacent to the canal which is on United States Bureau of Reclamation right-of-way. The fenced area does not prevent access to the pump house and discharge piping. There does not appear to be an easement or an access agreement between the District, the CCWD or the Bureau of Reclamation for the use of this site. Contacts at CCWD were not able to locate any original documentation for the use of this site for the pump facilities.

The area inside the fence includes a pump house, discharge piping, CCWD metering, dedicated telephone service for pump operation, and a PG&E 240/480 volt power drop to the pump house. The fenced site has no lighting inside the fence however there is a City street light located approximately 50 feet south of the canal right-of-way that does provide all of the lighting for the site. The discharge of the untreated water from the pump house is at an approximate elevation of 176 feet above sea level.

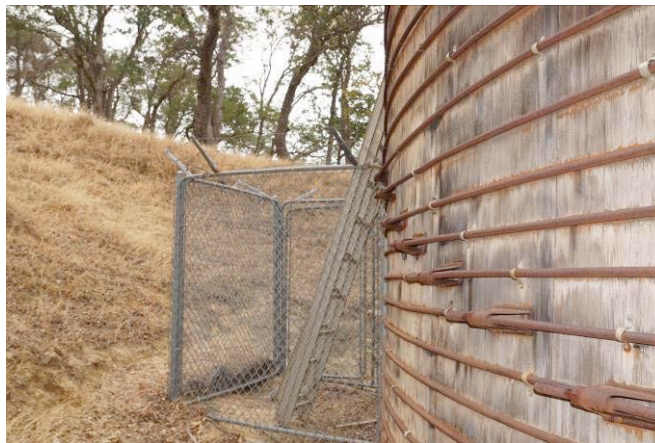
Figure 15: Tank Ladder Security Fencing

The inside of the tank is accessed by ladders (see Figure 13 and 14 below) along the southern exposure of the tank and over the top and back down the inside of the tank. The access ladders are secured within a five-foot fenced area topped with barbed wire (See Figure 15 below). The District has purchased a harness climbing system for anyone using the access system. The tank does not contain any access hatches or man ways for entry into the tank from ground level.

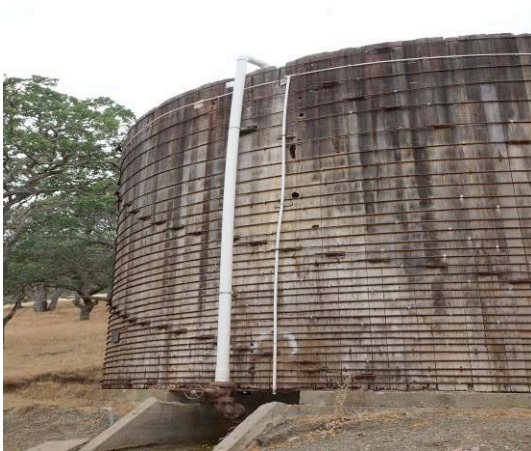
Figure 16: Tank Siphon Piping, Ext.

The bottom of the tank is at an elevation of 415.5 feet above sea level and approximately 240 feet above the District pump station discharge according to the original construction drawings. The tank fill and discharge line runs up the outside of the tank from the isolation valve to the top of the redwood and then back down the inside of the fiberglass insert to a discharge point about one foot above the floor of the tank. At the top of the storage tank the siphon changes direction and moves inside the tank at an approximate elevation of 436 feet above sea level. The tank is filled and discharged through a four (4) inch PVC siphon (See figures 16 and 17 below).
